IKA Report No. 15-0759-1

Salt Spray Test

Ordered by Gilad Kol
Lordan A.C.S Ltd.
Kefar Szold 12230, Israel

We received for salt spray test a heat exchanger designated by the customer as NanoGen2.

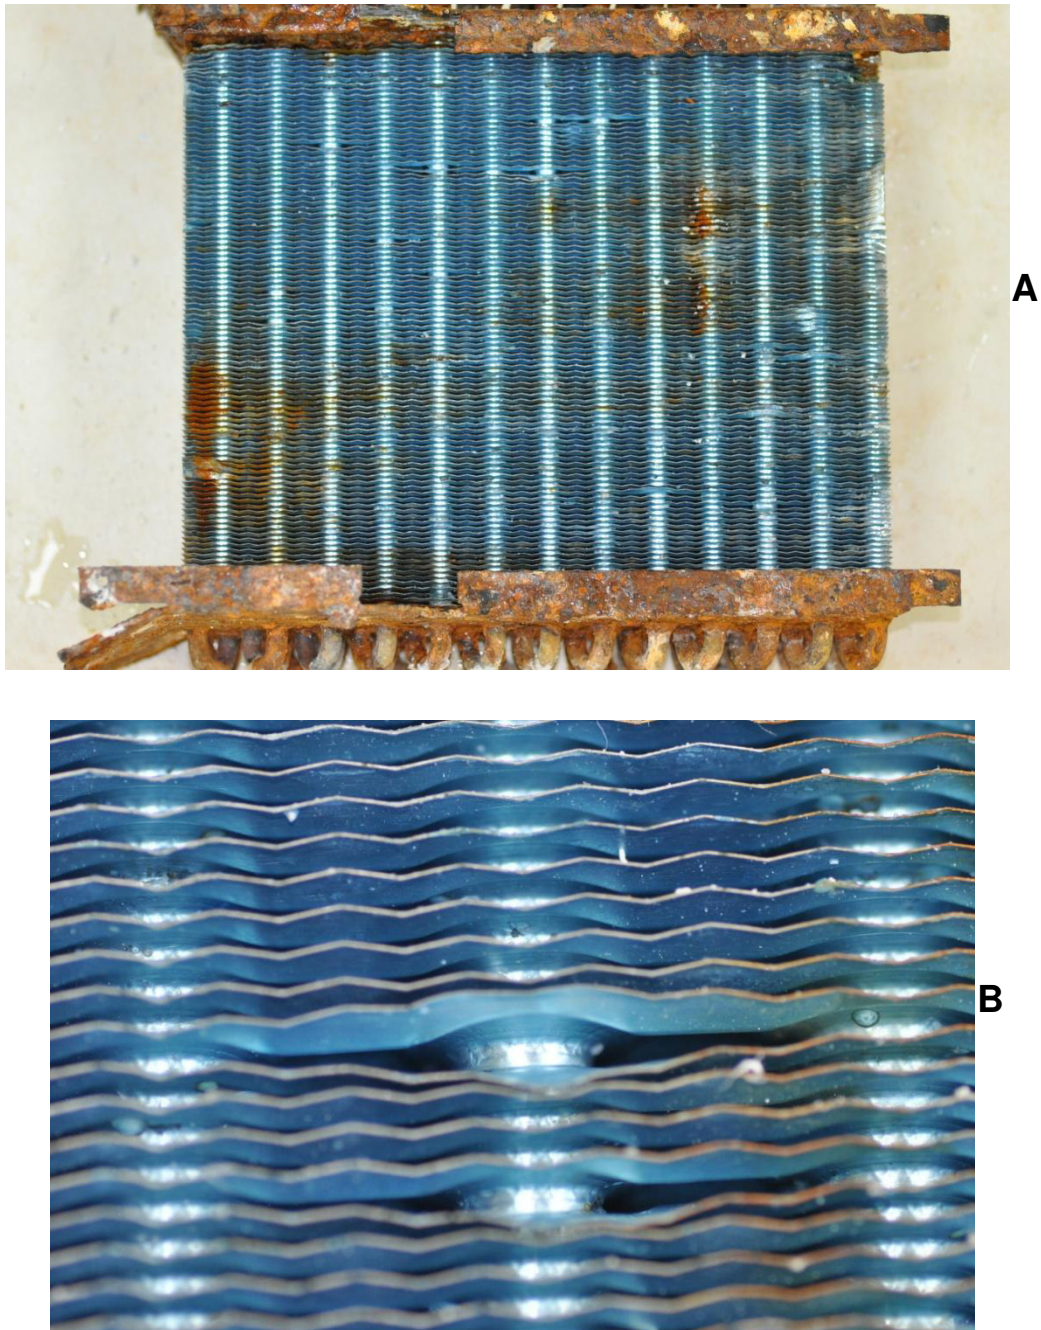
Figure 1

No sign of corrosion was seen at the areas of contact between the fins and the tubes.

- 3.1 No sign of corrosion was seen at the areas of contact between the fins and the tubes in the heat
exchanger after 5000 hours of salt spray test (the NanoGen2 coating is certified for 5000 hours
of salt spray test).

A- General view of the heat exchanger after 5000 hours of salt spray test

B- A close view at a fin collar where the fin is in contact with the copper tube
